ROCKY MOUNTAIN ARSENAL

**Annual Covers Report for Integrated Cover System
2015**

**Revision 0
November 25, 2015**

**U.S. Department of the Army
Shell Oil Company**

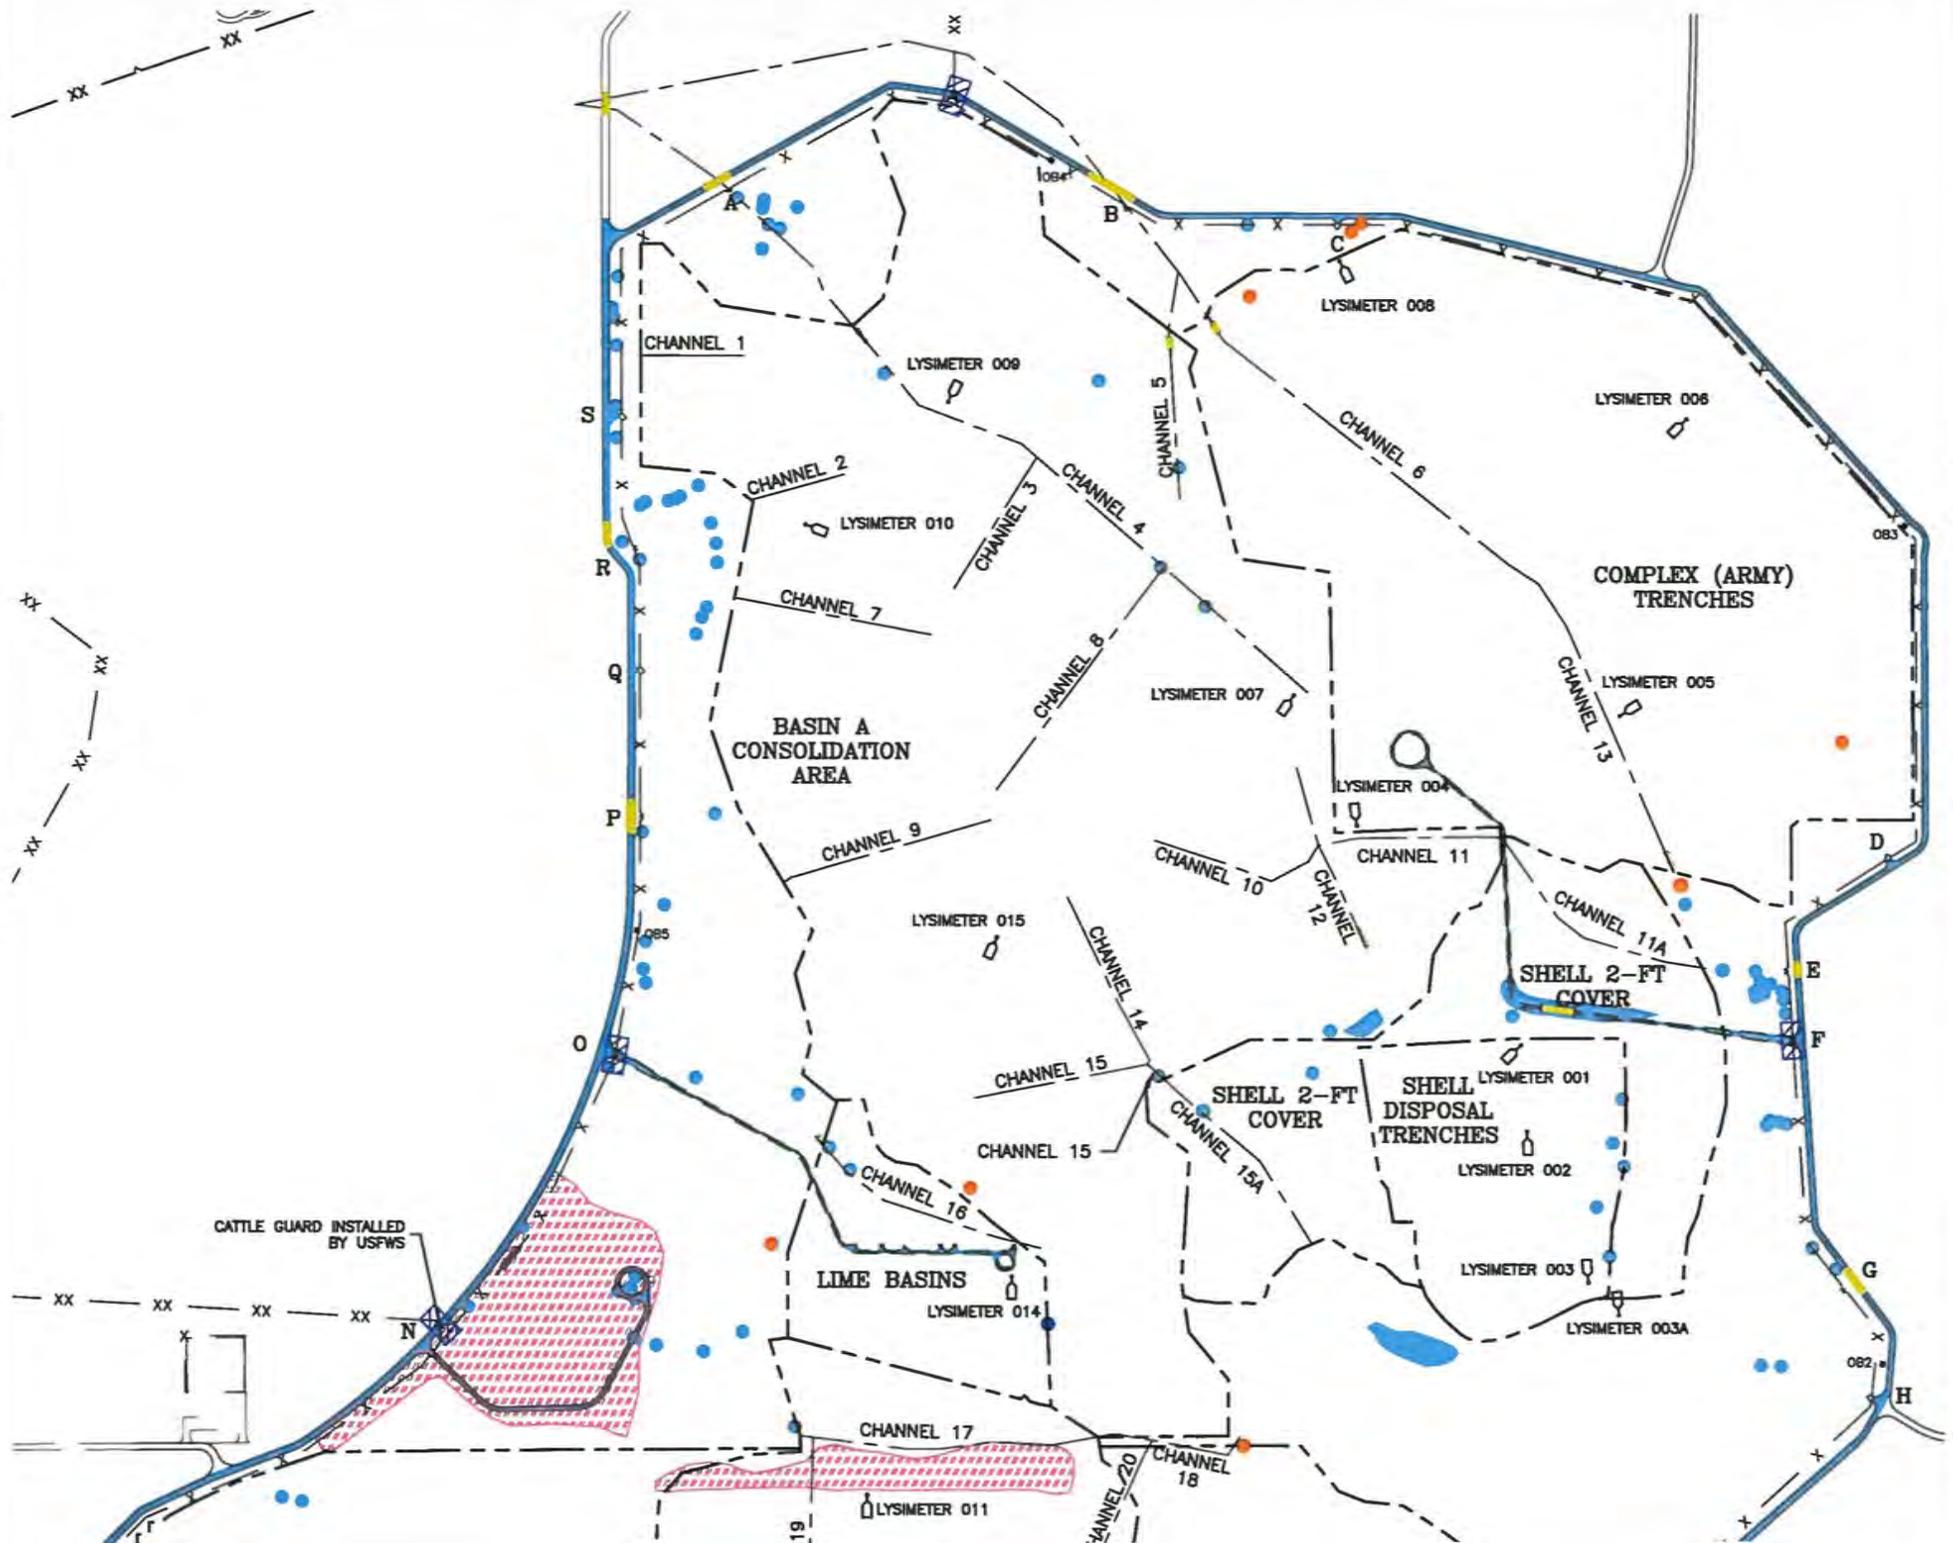
4.0-1	ICS Routine Maintenance Activities Map
-------	----------------------------------------

Ponding Areas or Other Conditions that Could Interrupt Cover Drainage: In October 2014, there were numerous repairs made to holes or other conditions that could interrupt cover drainage. The following points were repaired by filling the identified area with cover soil and then hand seeding the repaired area:

The areas repaired from the ICS fall 2013 Type II inspection include “waypoint 5 sinkhole” near point 540O on the east transects, “waypoint 3 sinkhole” near point 744N on the east transects, and “waypoint 1 localized settlement” near point 555K on the east transects.

The areas repaired from the ICS spring 2014 Type II inspection include “1-hole” near point 556J on the east transects, “6-washout/seed” near point 554K on the east transects, “16-hole to fill” near point 547O on the east transects, and “020-hole to fill” near point 539O on the east transects.

The areas repaired from the ICS fall 2014 Type II inspection include “001-hole” near point 702N on the west transects and “sinkhole” near point 743N on the east transects.

The area repaired from the ICS June 2014 Type I inspection includes the depression that was identified just northwest of Channel 16.

The holes that were observed at the outlet end of Channel 6 during the March 2015 Type I inspection were repaired in October 2015.
